Alexandria 1994: Archaeological Excavations

Polish Archaeology in the Mediterranean 6, 11-20

ALEXANDRIA 1994 ARCHAEOLOGICAL EXCAVATIONS

Grzegorz Majcherek

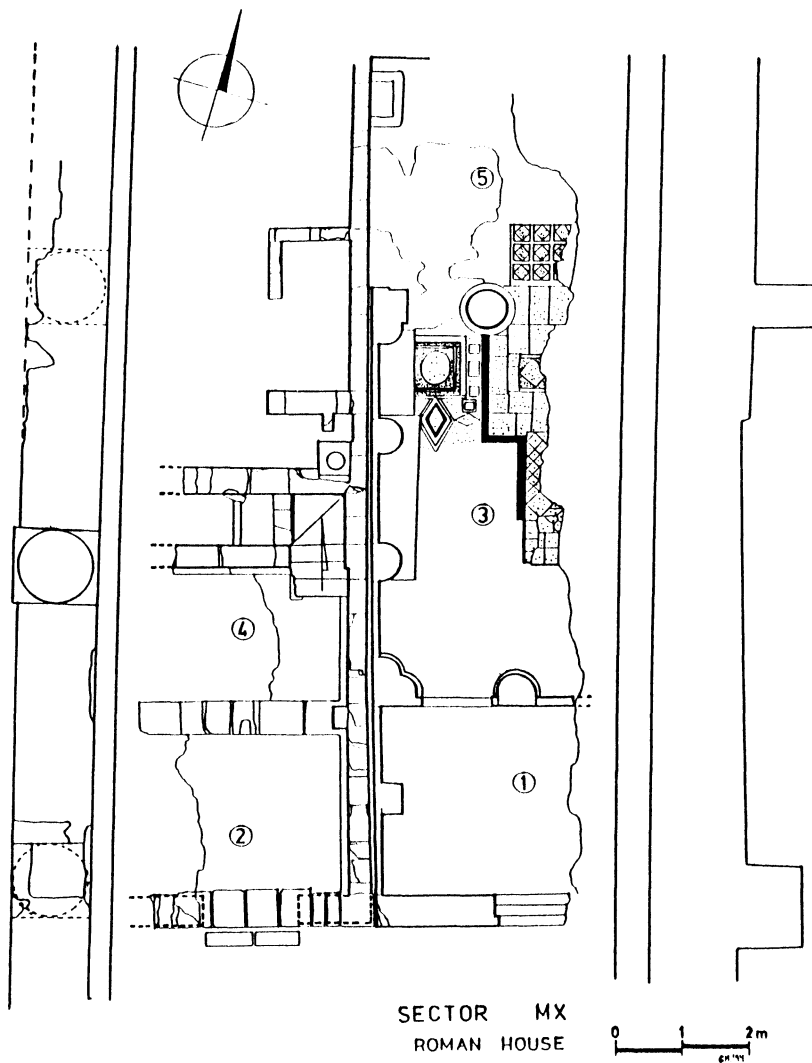
*Fig. 1. Plan of the Early Roman house unearthed in sector MX.
Drawing by the author.*

be two separate houses were cleared (loci 1 and 2 were excavated already in 1973). Of particular interest is house A, occupying the eastern part of the trench (Fig. 1). The entire available surface of a large loc. 3 was cleared, the rest having been destroyed by the wall of the theater. The room measuring originally some 6 by 6 m, seemed to be the principal, sumptuously decorated chamber of the house. It was accessible from the north through a tripartite entrance formed by two columns and framed with large pilasters. The interior decoration comprised pairs of engaged columns placed along the walls and similar double engaged columns (*Härzsaulen*) posted in the corners opposite the entrance, giving an overall impression of a pseudo-peristyle arrangement. Several, fragmentarily preserved capitals, cornices and architraves permitted a reliable theoretical reconstruction of the hall. The style of decoration indicates that the hall and supposedly the whole edifice was built at the end of the 1st century BC or the beginning of the 1st century AD at the latest.

The floor of the hall was decorated with a mosaic-like pavement. The central part was made of multicolored marble tiles arranged in a geometrical design: combination of squares, triangles and lozenges. Ample space along the walls was paved with smaller irregular pieces of stones in typical *opus signinum*. This gave the general effect of a T-shaped floor design, suggesting a *triclinium* rather than *oecus* or perhaps a combination of both. The *oecus-triclinium* opened on a courtyard which has not been fully excavated yet. Again, it was paved in the *opus signinum* technique save for a small area in front of the entrance, which was made of larger marble tiles set in a geometrical pattern. Next to the western wall of the courtyard a small rectangular pedestal of reused blocks was unearthed. It apparently served religious purposes as evidenced by several *ex-vota* found nearby: finely sculptured marble hand, foot imprint carved in a limestone slab, and a small but accurate model of a shrine or temple. Below the courtyard pavement remains of a

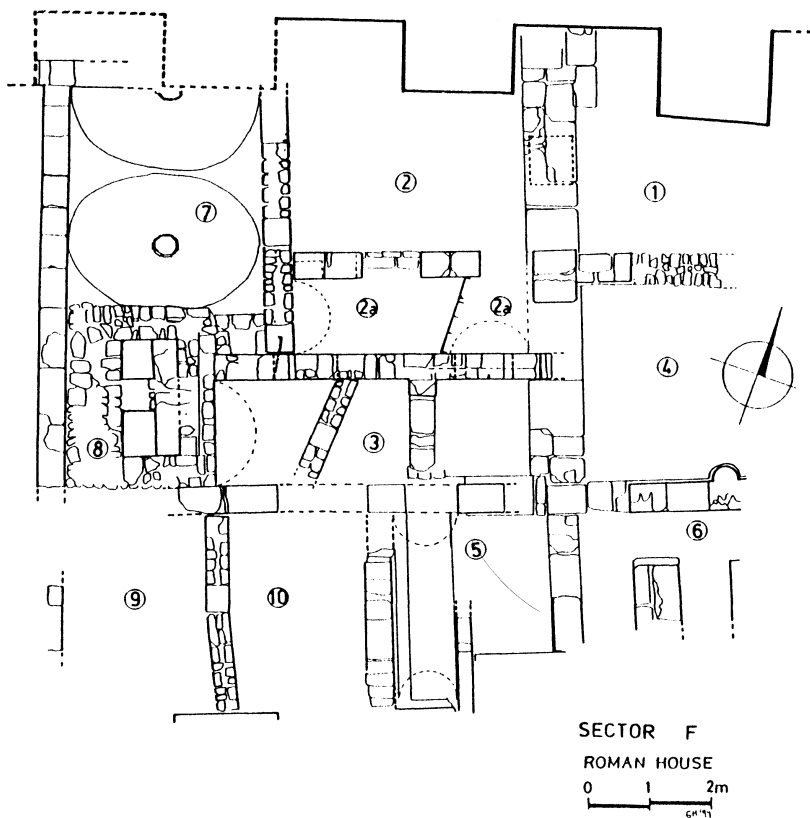
Fig. 2. Plan of the Early Roman structures excavated in sector F.
 Drawing by the author.

The building was originally constructed as a large urban house (Fig. 2). All the existing walls were uniformly built of regular dressed stone in *pseudo-isodomum* technique. The main entrance of the house has not been excavated yet, there-

fore the orientation of the building and its topographical relation to the street network remain unknown. It appears that the building represented a rather typical urban house plan, featuring a central courtyard and a series of rooms grouped around it. It should be made clear, however, that at this initial stage of research it is still premature to embark upon a hypothetical reconstruction of the house as a whole. The courtyard has not been completely cleared, but the explored part (3 by 7 m) has led us to assume, that it was designed as a pseudo-peristyle structure, decorated with engaged columns along the walls. One such column, adorning the southern wall of the courtyard has actually been excavated. It was a plain-shafted column resting on a low angular torus and topped with a regular Doric capital. The courtyard was paved with small chips of marble set in pinkish mortar.

Doors situated in the southwestern corner of the courtyard gave access to the staircase (loc. 6), pointing to the existence of a roof terrace or upper floor. No actual steps have survived, having been made presumably of wood as evidenced by the traces of supporting beams left on adjacent walls. West of the staircase, room no. 5 accommodated a two-chambered vaulted cellar, of which only the northern part measuring 0.80 by 3 m has been explored. The originally brick vaults were found to be almost entirely destroyed, save for an interconnecting stone arch which was preserved intact. Further to the west, there were two additional rooms (loci 9 and 10). They were only partly excavated, the seriously damaged walls preventing a thorough exploration. Both rooms were of roughly the same size (2.30 by 3.25 m), and both had separate entrances from the south, while at the same time they had no direct communication with the northern part of the edifice. This section of the building was somehow set apart from the main body of the house and must have served household functions.
