## Palmyra: Season 1999

# PALMYRA

## SEASON 1999

Michał Gawlikowski

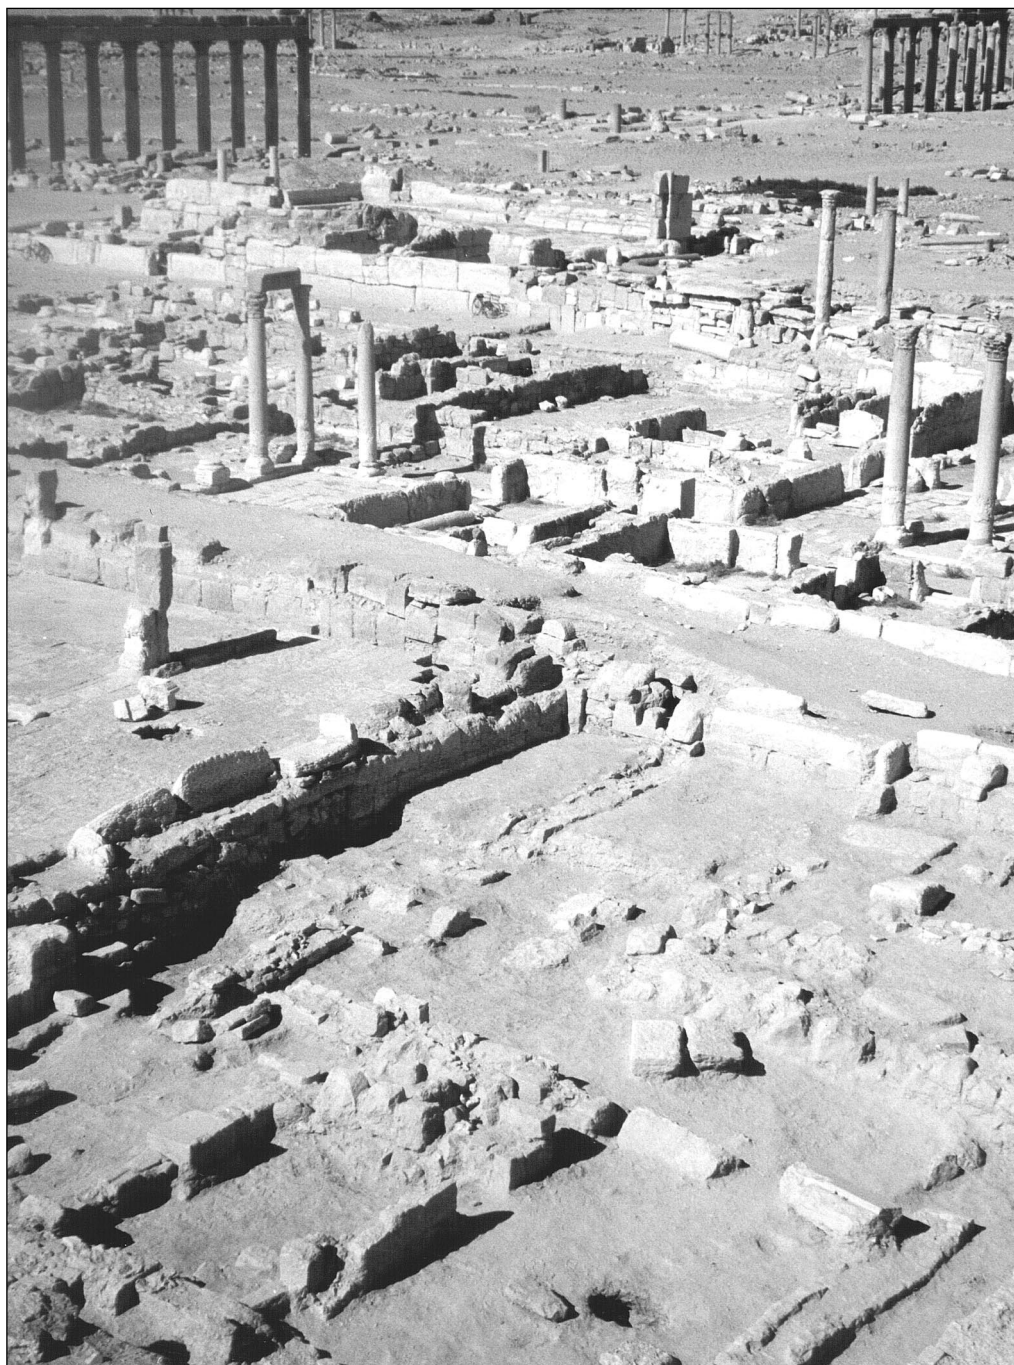
*Fig. 1. Excavations in 1999 with House F and Basilica I in the background  
(Photo M. Gawlikowski)*

*As a part of the long range program of digging and presentation of downtown Palmyra, the mission continued this year its excavations in a block marked G on Gabriel's plan, situated on the eastern side of the street coming up from the Great Colonnade, the so-called Church Street (Fig. 1). After having cleared in this area a residential unit and two churches, one of them a three-aisle basilica with adjoining baptistery (seasons 1997 and 1998), we have set out to investigate yet another basilica situated 33 m to the north. While the walls of the first church were systematically dismantled, apparently in the 9th century, the other church seems to be better preserved and offers hope for a partial restoration. Preliminary to this considerable task, we have worked this season in the sector between the two churches (area G 3). At the same time, a sector of the Great Colonnade opposite Block E was investigated again. Generally speaking, this season can be considered as preparatory. The five weeks in Palmyra were entirely turned to the coming season and the goals we plan to achieve next year.<sup>1)</sup>*

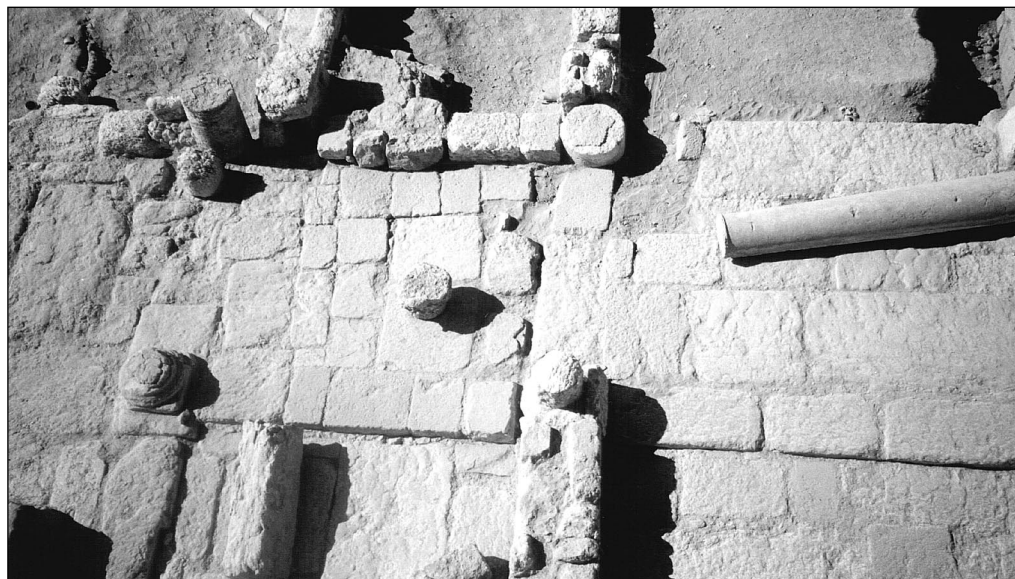
*Fig. 3. The paved atrium in front of Basilica III, seen along Church Street (right)*  
(Photo M. Gawlikowski)

After a careful inventory of the standing walls and fallen stones apparent on the surface, it was decided to tackle the empty expanse in front of the church. It soon appeared that this area, including the whole width of the street, is paved with huge, well fitted flagstones. In the middle, the paved area is slightly lower, forming a sunk rectangle around which some column bases were found in place. It is already clear that what we have here is a typical atrium (*Fig. 3*), a feature extremely rare in Syrian church architecture.

The fragment of the pavement cleared this year features five column bases of Attic type, 50 cm in diameter on top. In addition, one Corinthian capital and some broken architrave beams were found loose in the fill. All these elements are clearly reused. However, three bases are partly hidden by

the flagstones and apparently remain in their original position. Two of them are aligned with the western side of the Church Street, and one with its eastern side. On the other hand, the two remaining bases closer to the church are set on the pavement; no doubt, they were originally aligned with the east side of the Church Street.

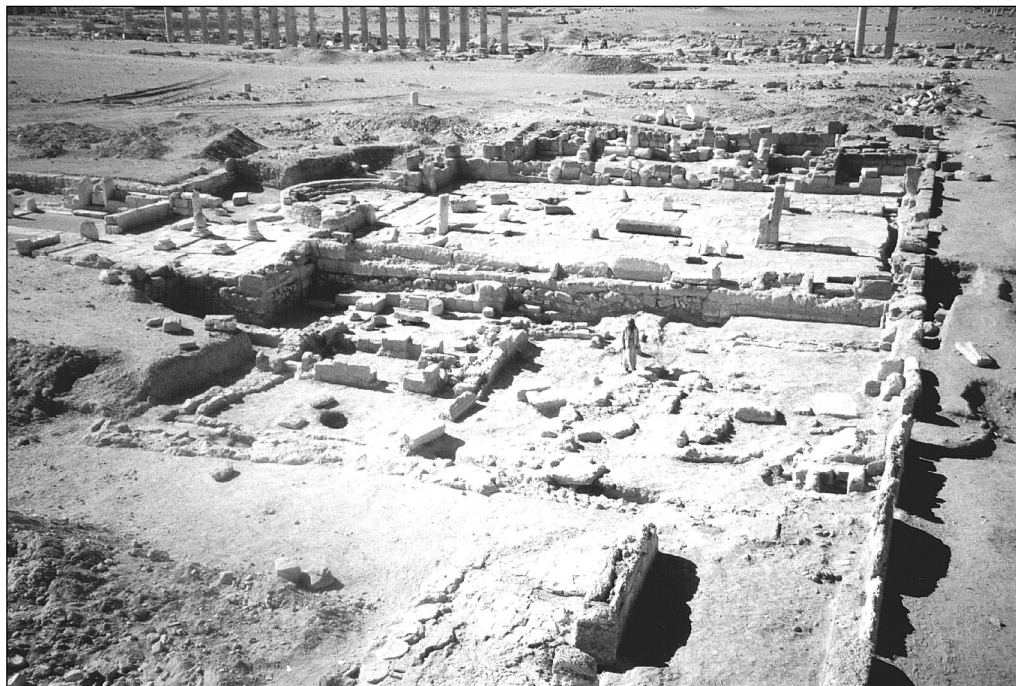
*Fig. 5. General view of area G 3 to the south with Basilica II in the background (Photo M. Gawlikowski)*

II, and on the west by the Church Street. It is filled with ruins preserved to levels between 0.80 m and 1.80 m below the pavement of the adjoining church (*Fig. 5*).

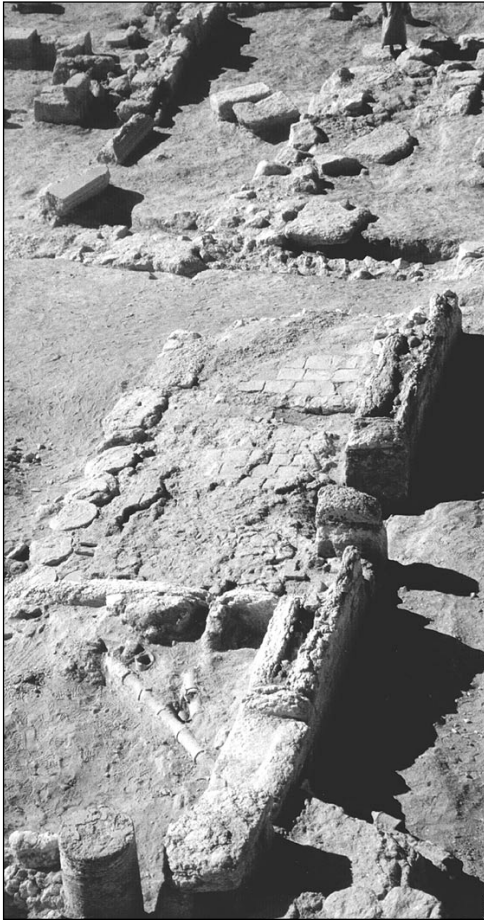
Fig. 6. The water tanks (G 3.5) close to the atrium of Basilica III  
(Photo M. Gawlikowski)

Last year three fragmentary floors one upon another, all of them made of baked bricks and waterproof mortar were found in the northwestern corner of locus G 3.3 (Figs. 6 and 7). The uppermost floor reaches a level about 70 cm above the room floor. This has become clear only now that part of the area to the north with the structure marked as G 3.5 has been excavated.

A floor of baked bricks (32 by 32 cm) and ash mortar was found there, at practically the same level as in G 3.3, together with the outlines of a brick enclosure doubling on all sides the stone walls, contemporary and earlier, and blocking the original door to G 3.4. They were laid on a substructure comprising vertical column drums packed closely together and some other huge blocks, suggesting that a heavy load was expected to fill the basins installed above. The one whose entire surface is preserved measured 4 x 2 m; the other one is barely half this length. The pipes laid in G 3.4 and in an open space north of the basins provided for the inflow of the water and its outflow toward the conduits running under the surface of the Church Street.

Seen in this light, the irregular heaps of stones found under the floor level of G 3.3 should be understood as the superstructure of similar basins founded on the ruins of this room in two parallel rows. The floor of one of them was fragmentarily preserved, as mentioned above. We would have thus at least six tanks measuring about 4 x 2 m, allowing for the storage of well over 100 m<sup>3</sup> of water.

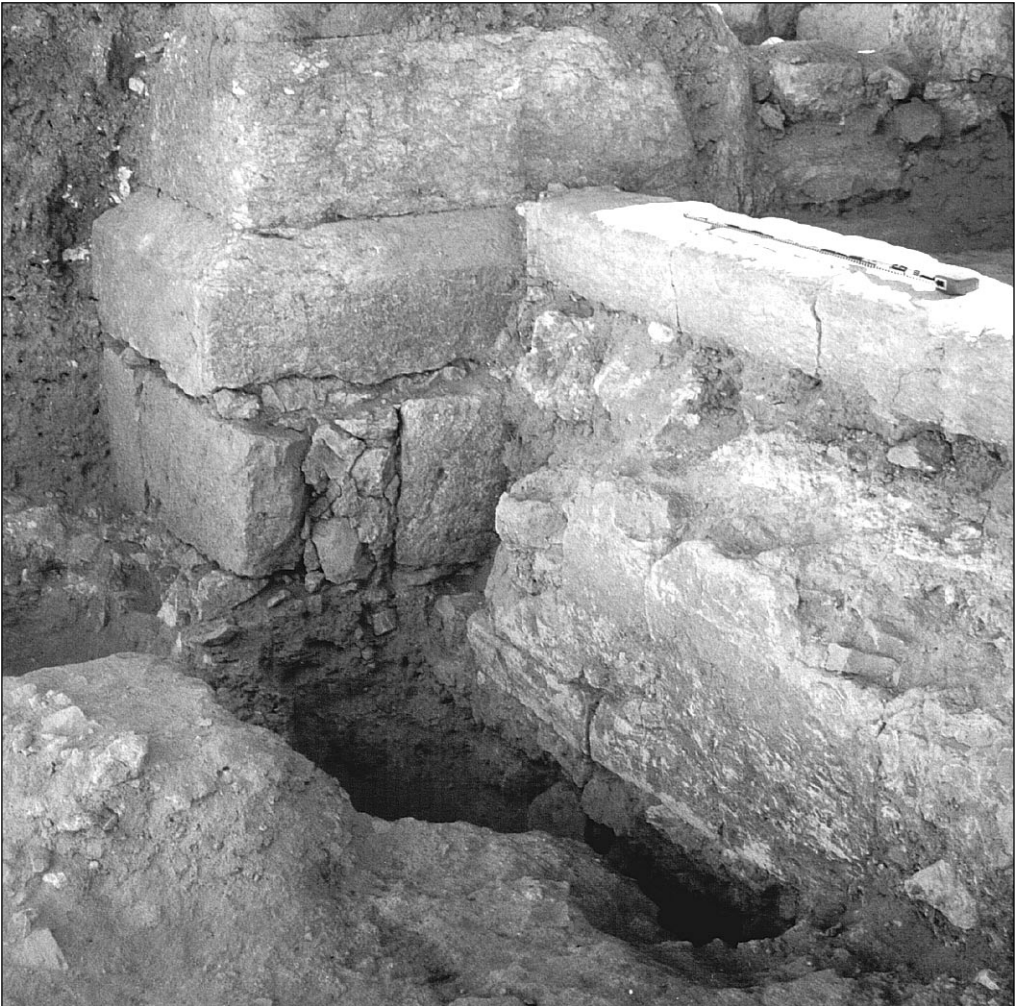
*Fig. 9. The base of a corner pillar of Oil-Press Street, cutting across an early foundation of the Great Colonnade (Photo M. Gawlikowski)*

ancient levels. Beyond, there ran a cross street (Oil-Press Street) of which two corner pillars were found, the border of the portico pavement joining one of them (*Fig. 9*).

The most interesting, however, was the discovery of a perpendicular wall below the street level. It was cut by the foundation of the corner pillar and is therefore older than the Colonnade. The
