Bricks and Brick Bonding in the Monastic Architecture on Kom A in Naqlun

Polish Archaeology in the Mediterranean 15, 152-158

BRICKS AND BRICK BONDING IN THE MONASTIC ARCHITECTURE ON KOM A IN NAQLUN

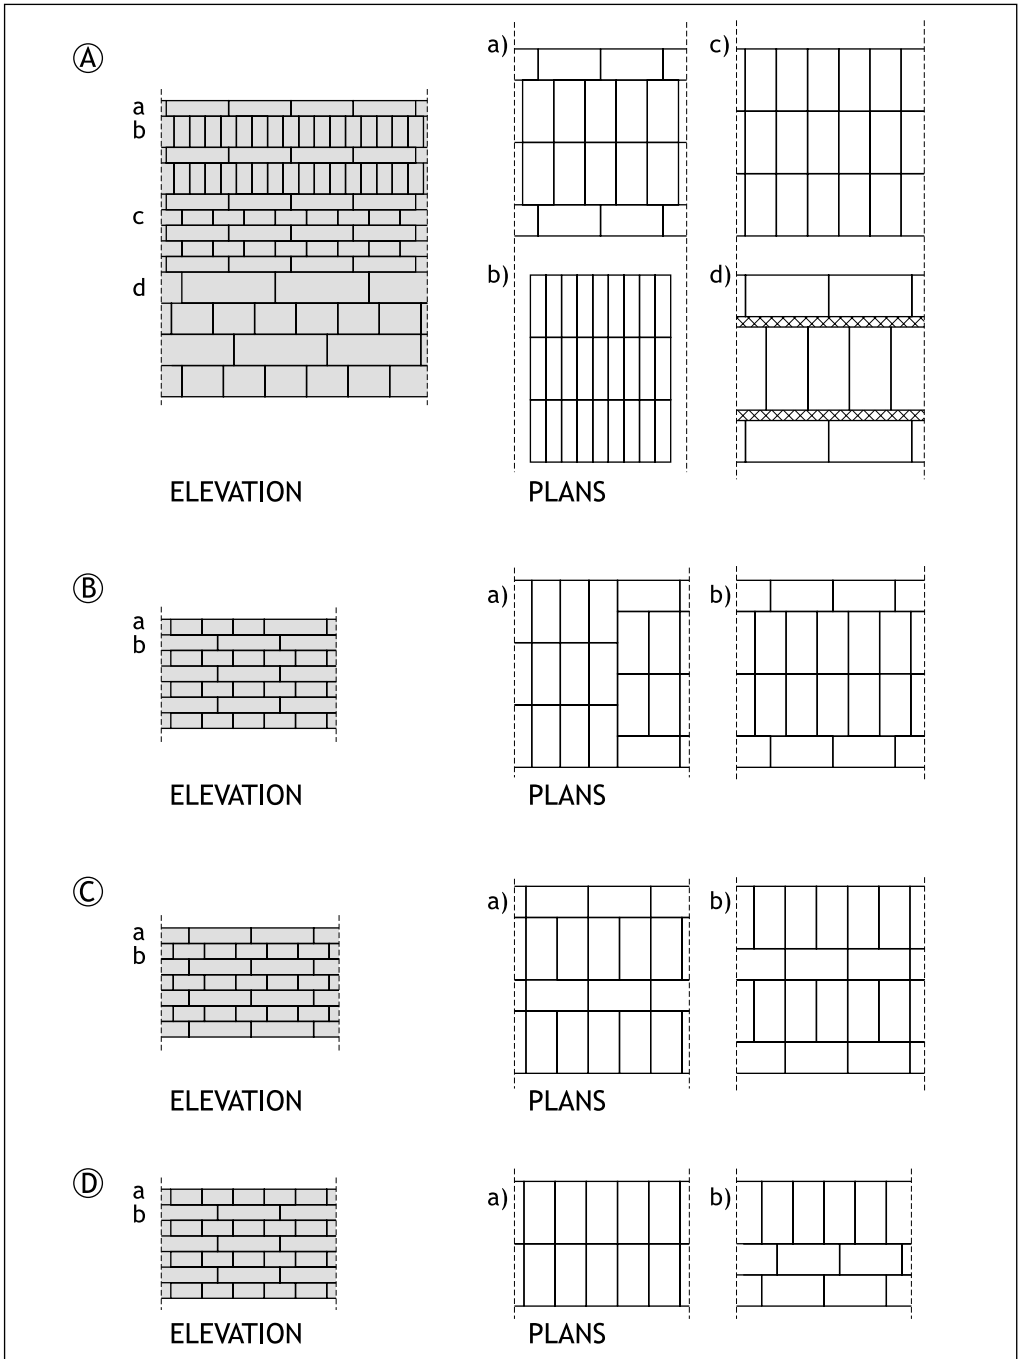
Fig. 1. Examples of bondwork encountered on Kom A in Naqlun
(Computer rendering A. Błaszczyk after drawing by Sz. Maślak)

The architectural remains on Site A and its borders are relatively diverse as far as the brick bondwork is concerned. Particularly noteworthy is the bond seen in the walls of building AA.30.1-3,17)¹⁷⁾ and especially room AA.30.2 (*Fig. 1.A*). The bottom parts of the walls (76 cm thick)

were raised of big bricks laid in courses of alternately headers and stretchers. At a height of c. 110 cm, the big bricks were replaced with smaller ones, although the rhythm of header and stretcher courses was retained for the next four courses. The upper parts of the walls demonstrated alternating courses of headers on edge and stretchers, which was a bond made popular in Egyptian building in Graeco-Roman times and common in the architecture of later periods.¹⁸⁾

Other walls of considerable thickness (66-70 cm, i.e. three brick lengths) from Site A, relatively rare on the whole,¹⁹⁾ were erected of flat-laid bricks, alternating headers and stretchers. Differences are to be noted only in the plan of particular courses (*Figs. 1. B and C*).

Some of the walls of moderate thickness (47 cm, i.e. two brick lengths) also represent the flat-laid brick bondwork. The southern section of the wall between rooms G.1 and G.2 (Building G), between the entrance and the staircase, had the west face made of courses of, alternately, stretchers and headers (*Fig. 1.D*). The wall between rooms G.2 and G.3 was made of stretchers alone, with headers every second course solely at the end, near the door (*Fig. 2.E*).

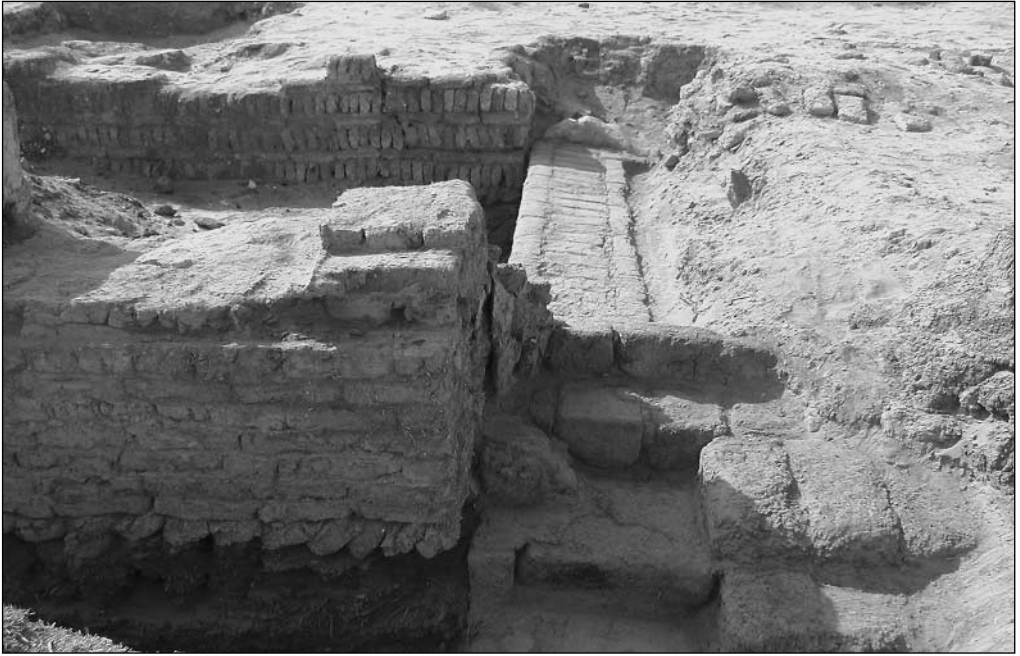
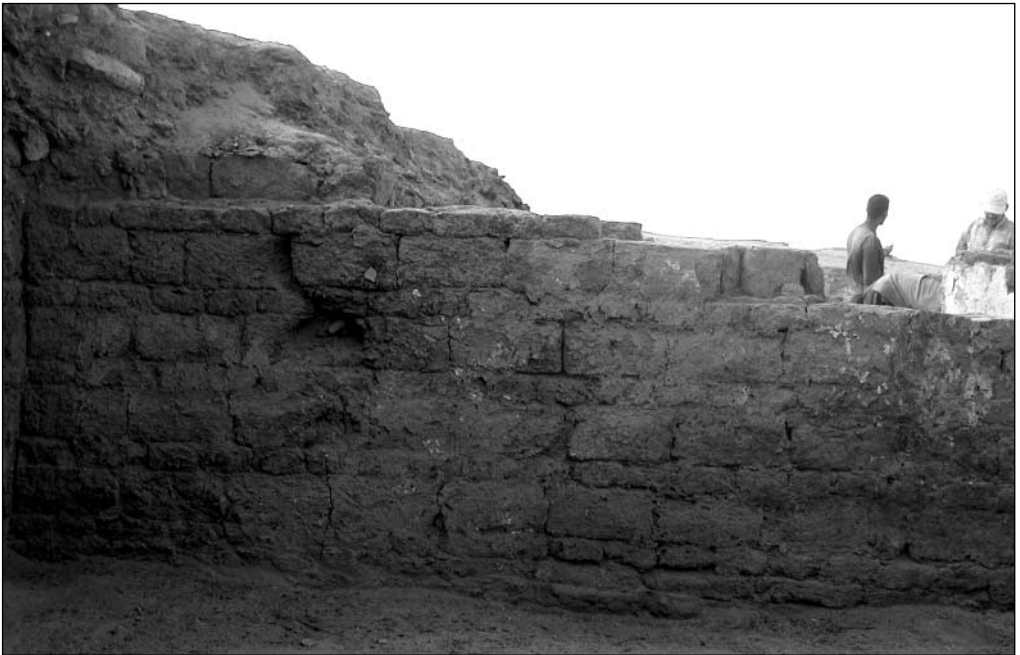
*Fig. 3. Examples of different bondwork from the excavations on Kom A in Naqlun
(Photo W. Godlewski)*
