Security Dimensions. International & National Studies nr 1 (21), 62-74

2017

SPECIFICITY OF LEAKING NITRIC ACID FROM A TANK VEHICLE

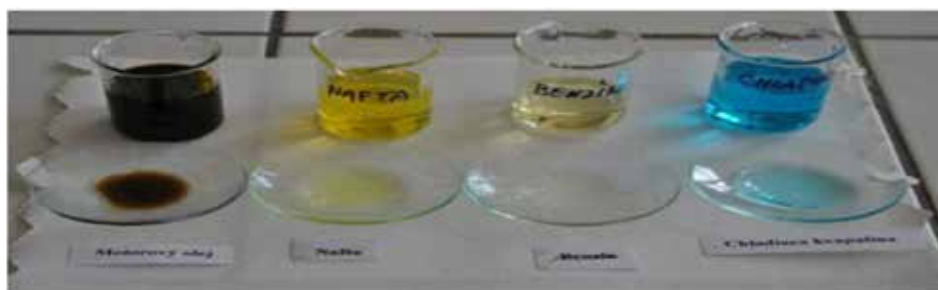
FIGURE1 SAMPLES OF OIL, DIESEL, GASOLINE AND COOLANT

Nitric acid solution (65%) in amount of 2 ml was applied in the each sample of fuel, fluids (Fig.1). and solid materials (Fig.2). In the case of a fuel tank and fluid that was a 1: 1 and 1: 5 (5 parts by fuel and 1 part HNO_3), and the oil was still a ratio of 13: 1 (13 parts of oil, and 1 part HNO_3). Subsequently, the changes in temperature and pH of the solution as well as the reaction were tracked.

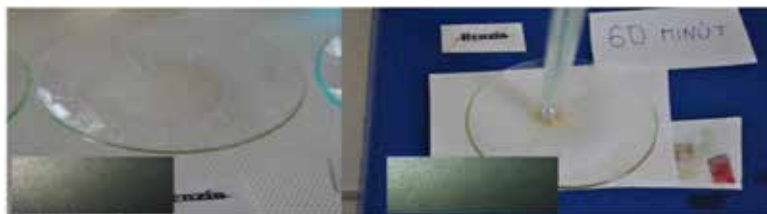
FIGURE 4 GASOLINE SAMPLE BEFORE THE EXPERIMENT, AND WITH HNO_3 IN A RATIO OF 1:1 AT 60 MINUTES AND MICROSCOPIC IMAGES

The reaction of the gasoline and nitric acid in a ratio of 1: 1 was carried out without major changes and reactions, see. Figure 6 and Table 2. There was only a change in the color of gasoline. It became pale and the clear boundary between gasoline and acid was visible. There has thus merging them. In a test at a ratio of 5: 1 (5 parts of gasoline and 1 part acid) solution of gasoline and acid the yellow colour was visible. For both reactions, there was a small increase in temperature, but this was due to the influence of the external environment.

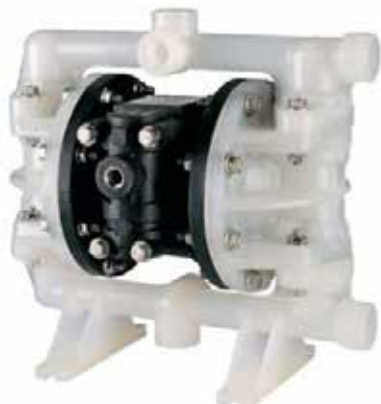
FIGURE 6 PNEUMATIC ACID DIAPHRAGM PUMP

With the loss of tightness it is important to try to close the leak sealing compound (acid-resistant) and acid then need to be pumped into another tank or vessel. The pump used must be acid-resistant, which is the most

frequently made of plastic (Figure 6). If the damaged tank has the empty chamber (section) the acid can be pumped out of the damaged section in to the blank section, which is standardly left empty from safety reasons.

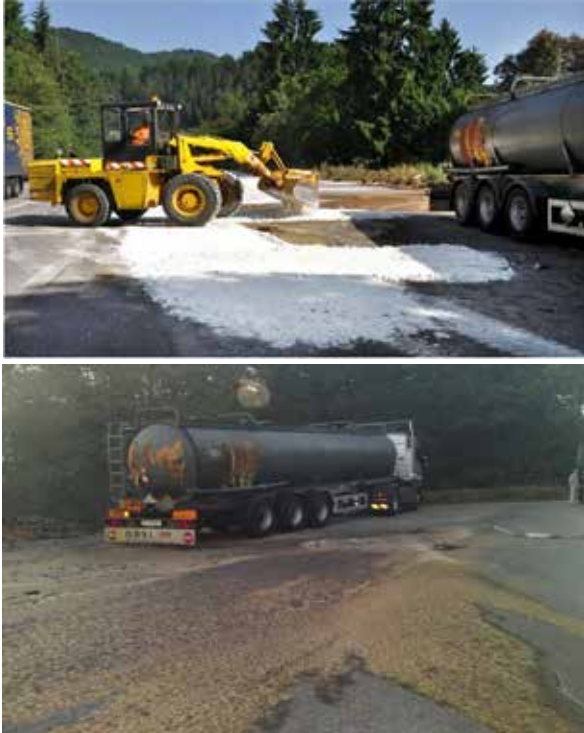
FIGURE 7 NEUTRALIZATION OF NITRIC ACID LEAK HYDRATED LIME

Nitric acid is most commonly disposed off by neutralization with hydrated lime. A further decontamination agent can be sodium carbonate or

potassium carbonate, or a solution of lime milk. Also improvised materials can be used e.g. a soil, a sand, a crushed limestone or a cement.
